# New York State Department of Transportation

## PIA Safety Flag NB23CTW008

**BIN: 1065318**

**Feature Crossed: 6TH AVENUE**

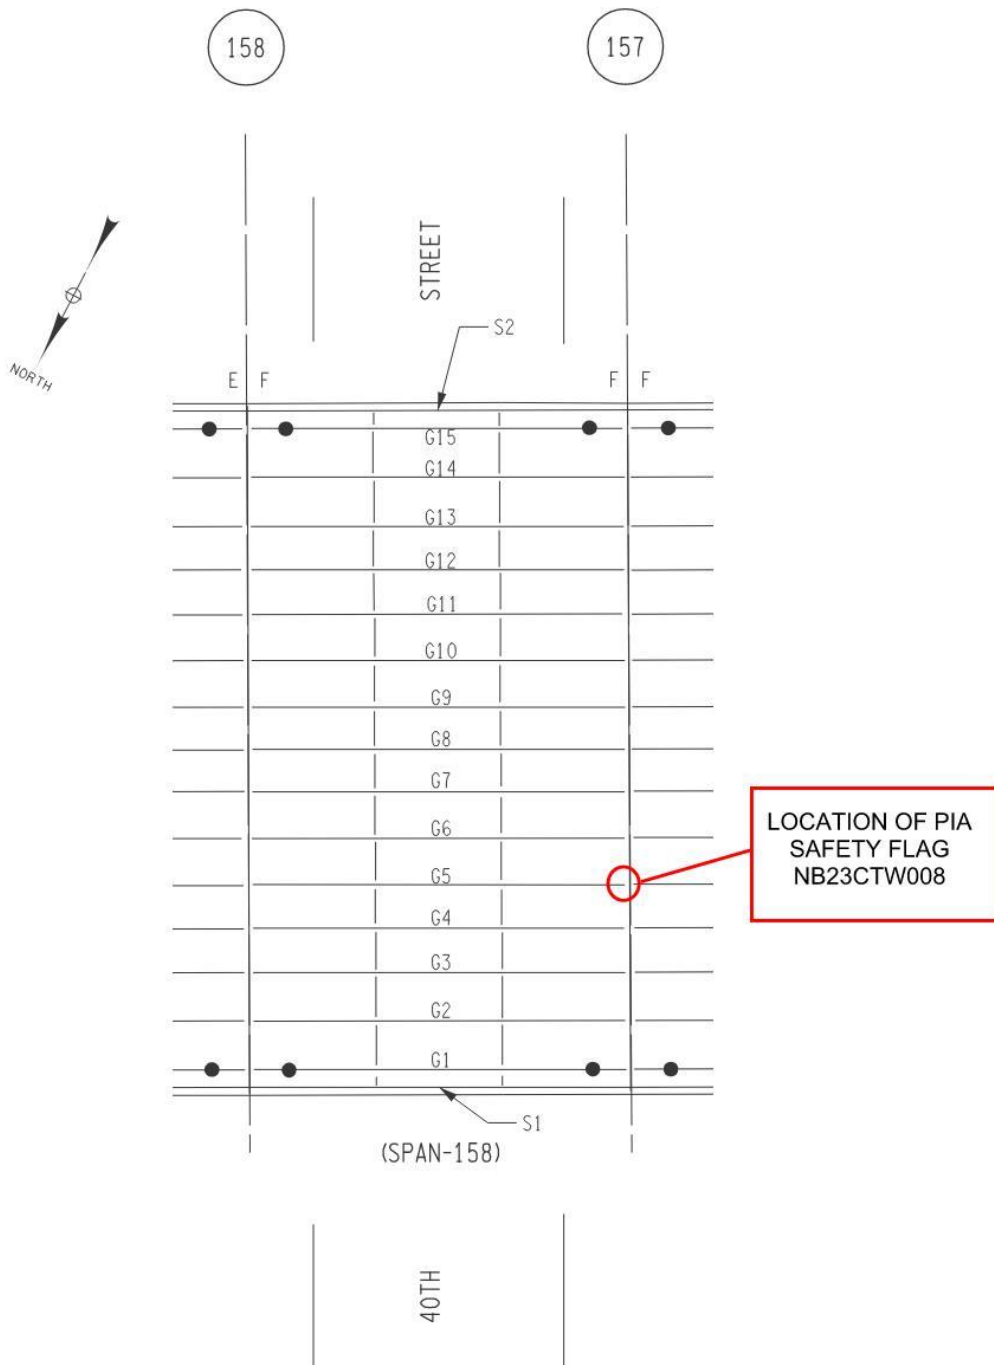
Photo Number: 1

**Attachment Description: Flag Location Plan.**

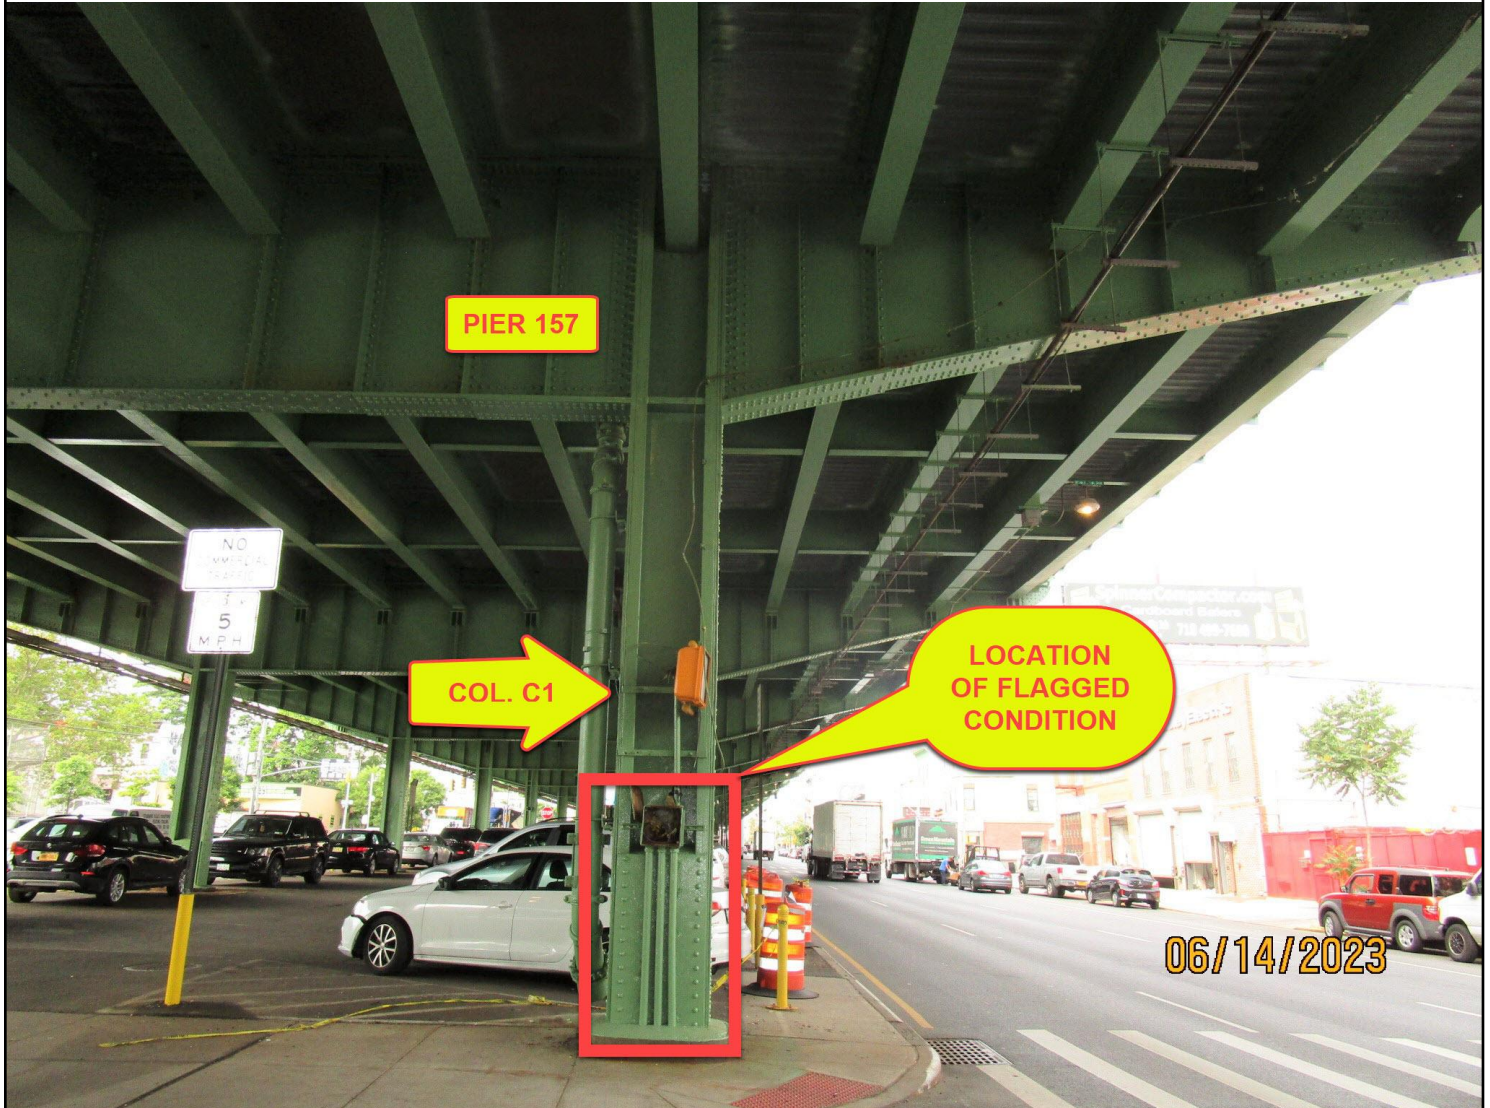
Photo Number: 2

**Attachment Description: General view of Flagged location. Looking Begin.**

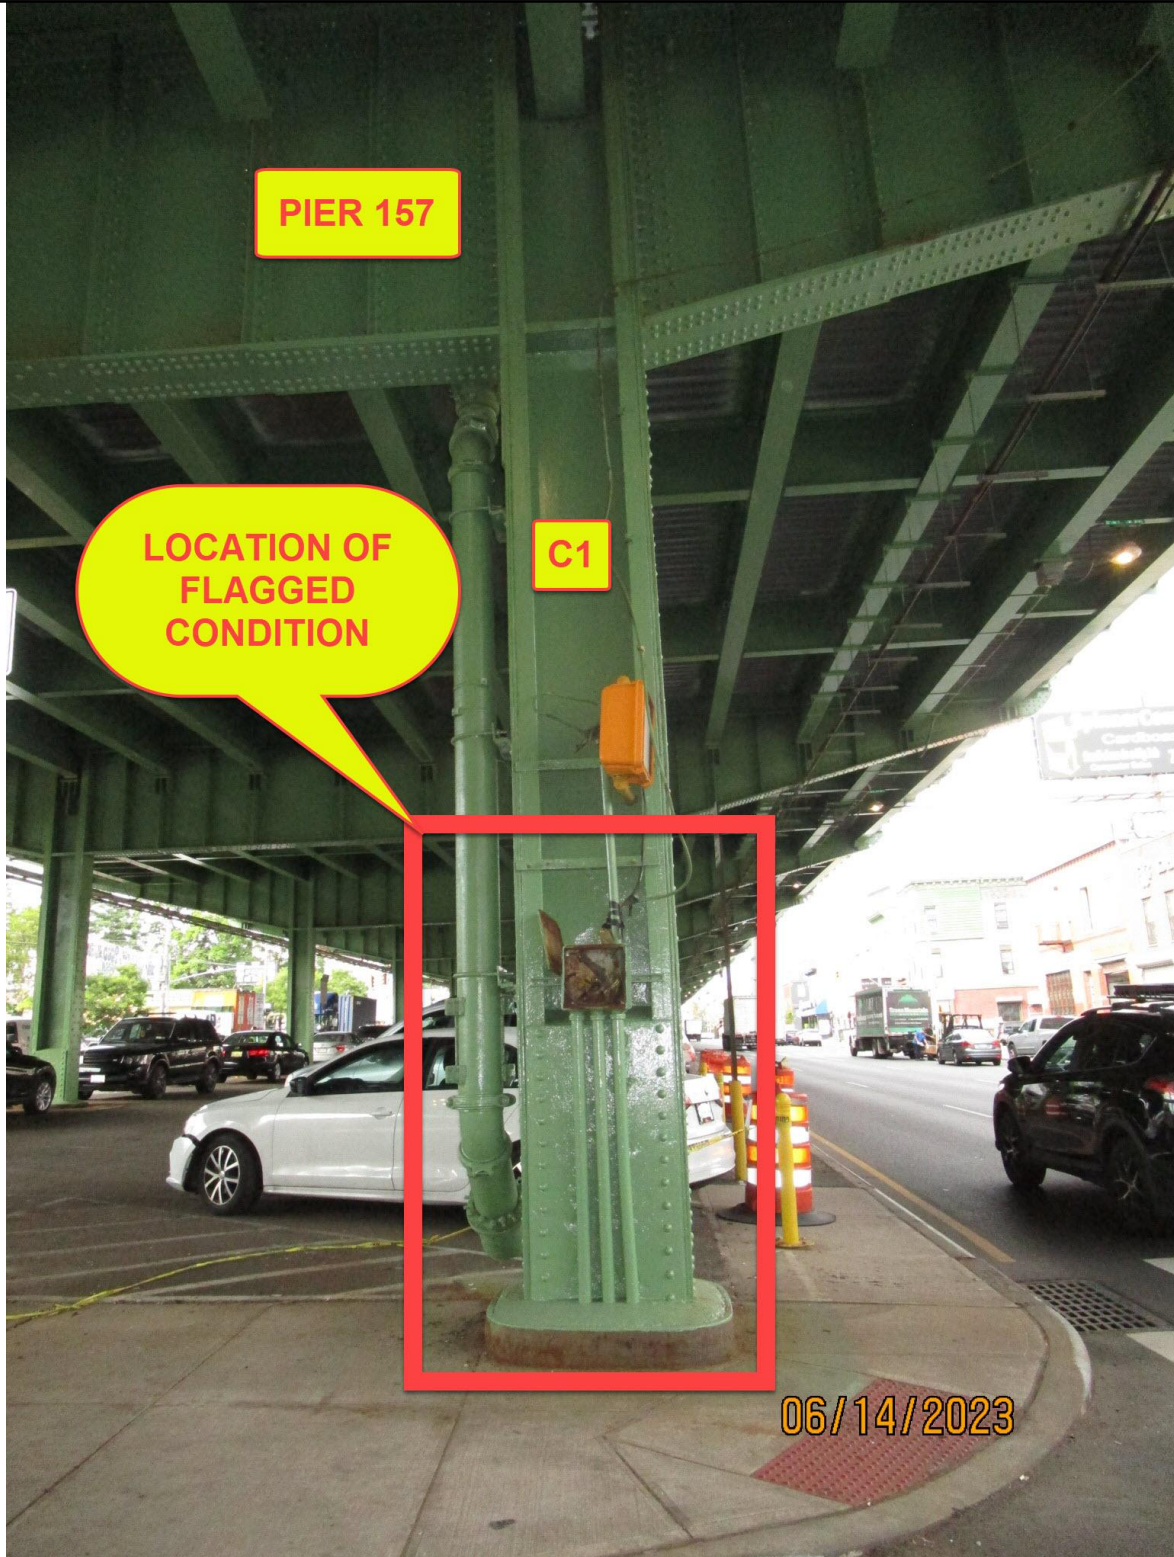
Photo Number: 3

This PIA Safety Flag No. NB23CTW008 is a New Flag.  
Location: Span 158, Pier 157, Column C1 at the base.

**Attachment Description:** Location of Flagged condition at Pier 157, Column C1. Looking Begin.

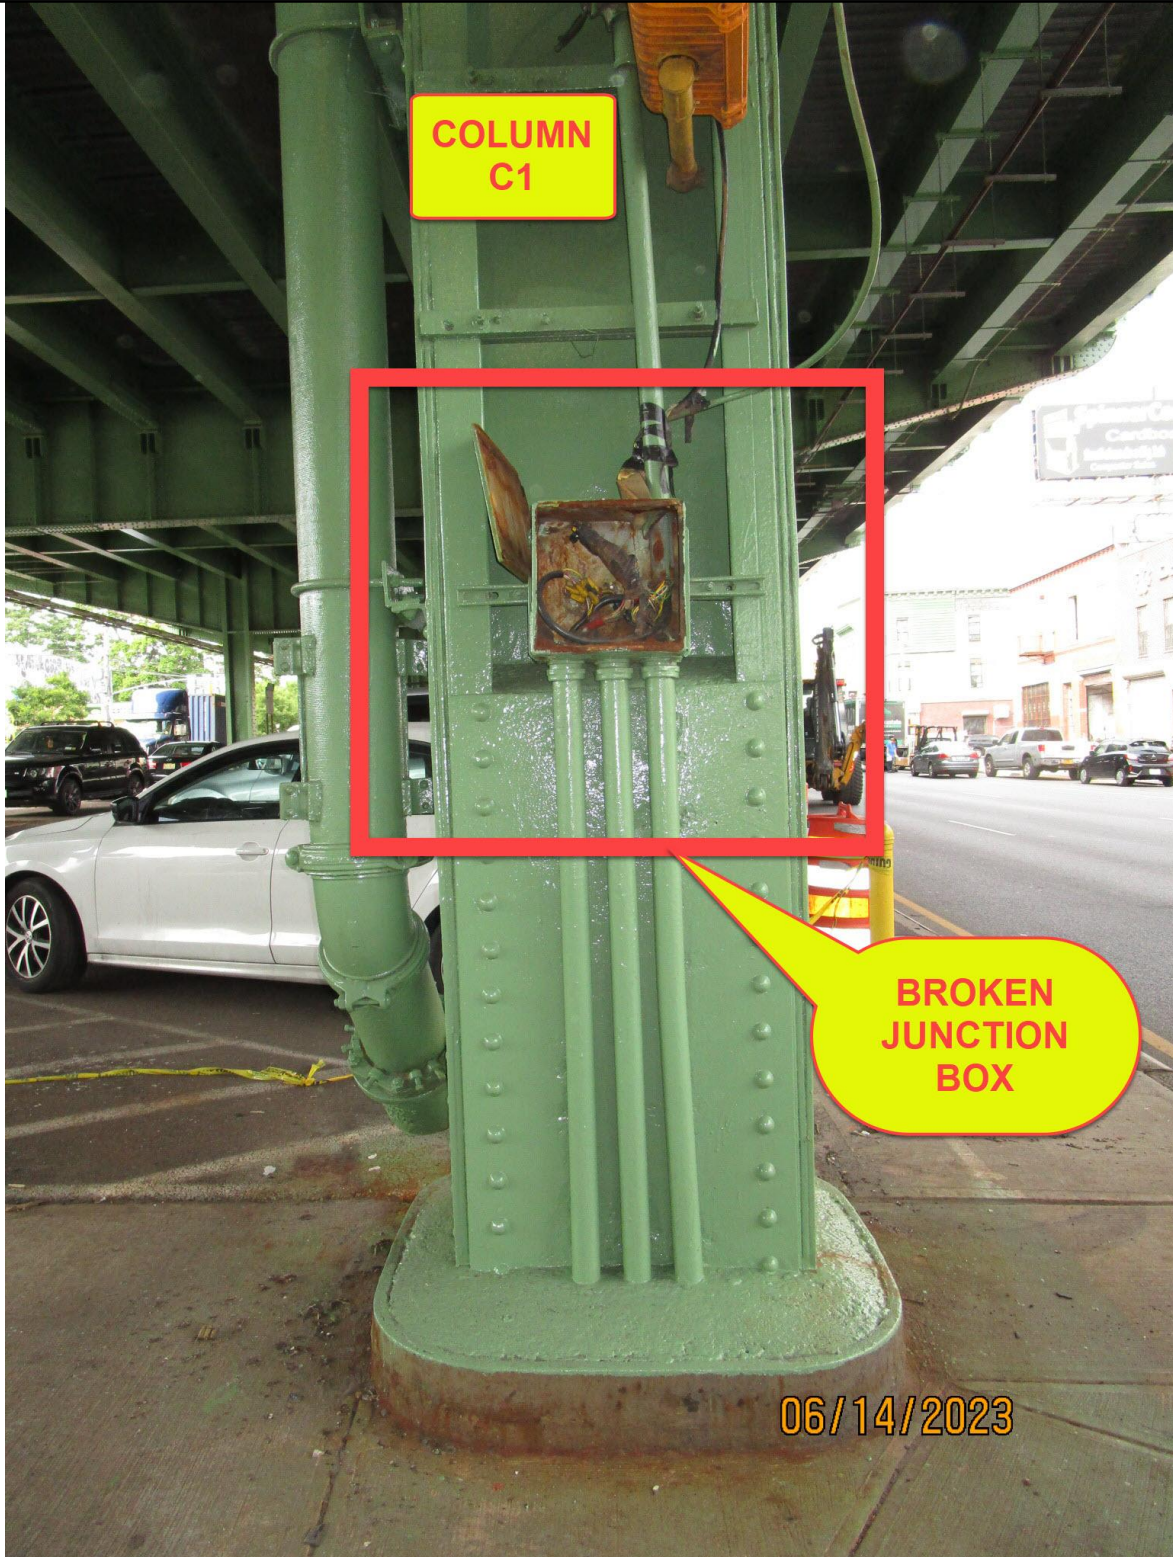
Photo Number: 4

At Span 158, Pier 157 Column C1, End face, there is a corroded and broken electrical junction box which exhibits exposed live wires. The condition is at the base of the column, and is accessible by the public.

**Attachment Description:** Close-up view of the broken junction box at Column C1. Looking Begin.

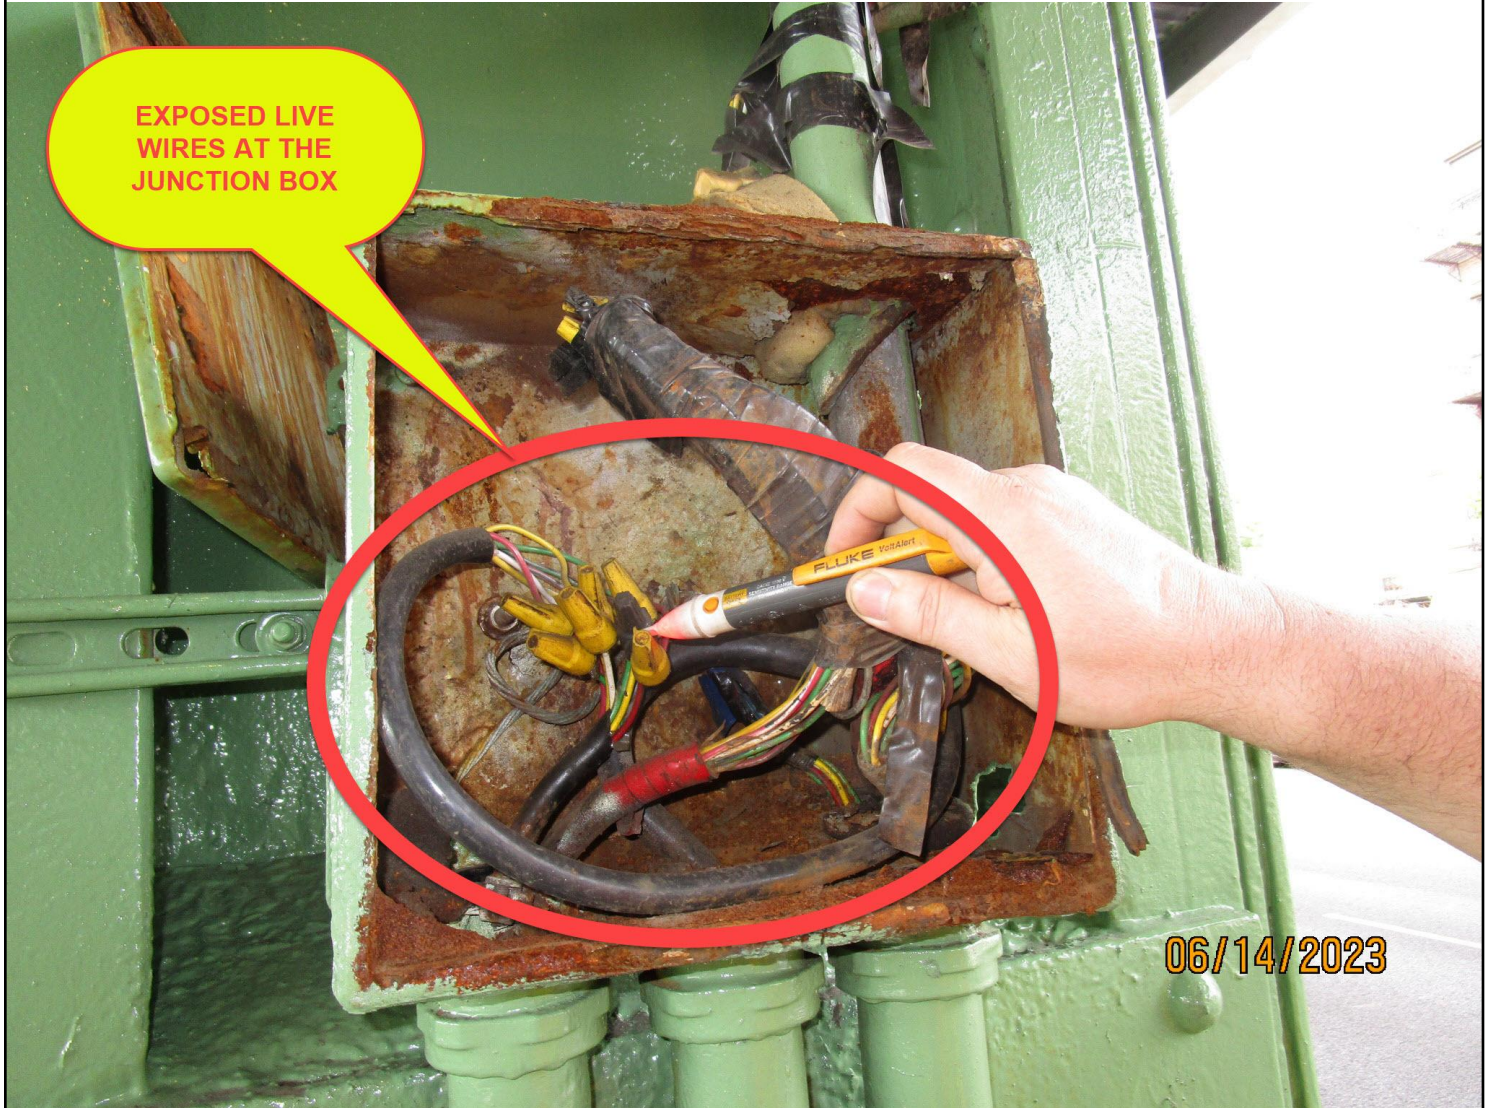
Photo Number: 5

**Attachment Description:** Non-contact voltage detector indicates live wires at the junction box. Looking Begin.
